The Use of Closed-Cell Spray Polyurethane Foam (ccSPF) to Enhance the Structural Properties of Wall and Roof Assemblies

By Mason Knowles

This article discusses field observations and research that document the ability of closed-cell spray polyurethane foam (ccSPF)¹ to add structural strength to roof and wall assemblies.

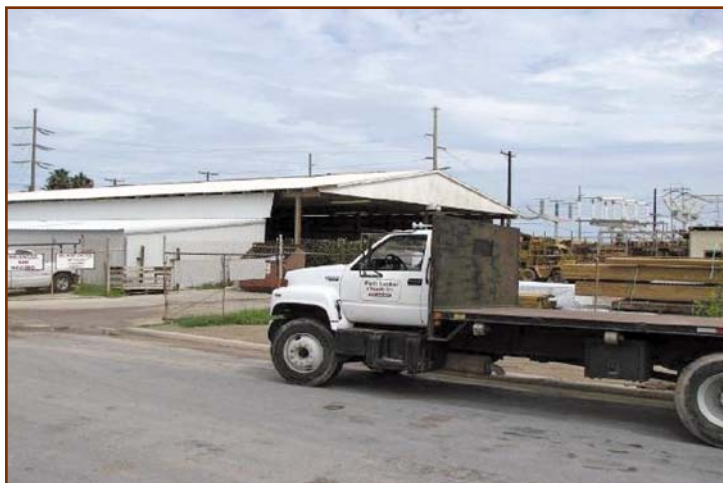
Figure 2 shows White's Lumber's open-end, post-frame-construction building. New metal was installed to half of the building (right side of the photo) in 2008, and the old metal originally installed in 1980 is on the left. For close to 30 years, there were no significant wind events in the area.

Figure 2 – The author installed the old metal roof on this building in 1980. A new metal roof was installed in 2008 on the right side of the building.

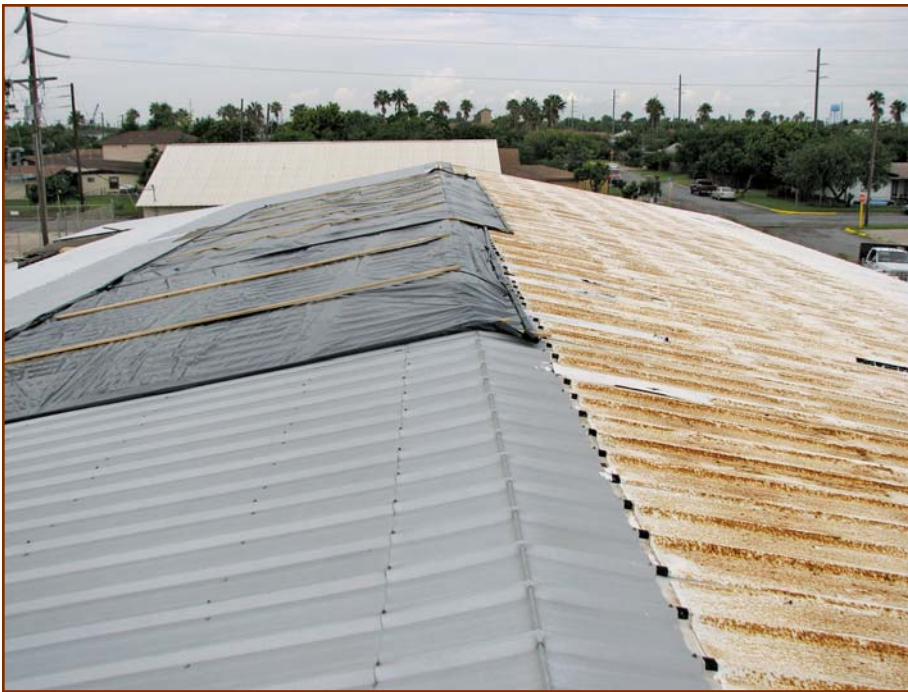
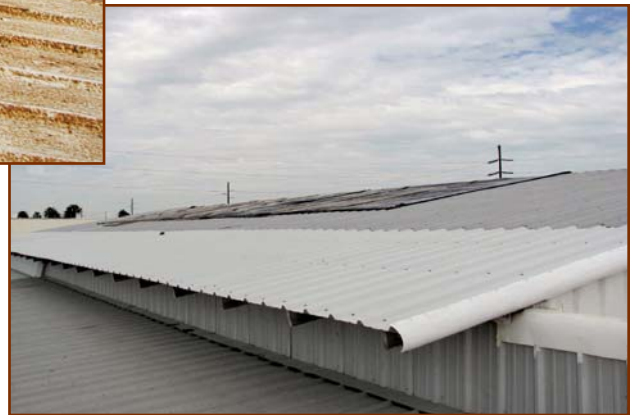
Figures 3 (left) and 4 (below) – Half of the roof blew off of White’s Lumber during Hurricane Dolly.

Lumber and Supply lost half of its roof, as shown in *Figures 3* and *4*. But something looks strange, doesn't it? The left side of the building has a new metal skin installed in 2008, while the right side has metal panels that are over 29 years old. As can be seen, the new metal blew off in the storm, while the old metal remained in place. Both are 29-gauge metal² with similar fasteners and fastening patterns (in fact, the new metal portion had a closer fastening pattern than the old section, and both are fastened to the same wood framing).

There is a simple explanation. When the metal was replaced in 1980, the owner contracted with the author to install a 2-lb, closed-cell spray foam in a “picture frame” pattern to help secure the metal panels to the wood trusses. Twenty-nine years later, this safety net proved invaluable (*Photo 5*). Unfortunately, when the owner replaced the metal on half of the building in 2008, he could not find an SPF applicator to replace the foam (*Photo 6*). Consequently, high winds blew off major portions of the new metal panels.

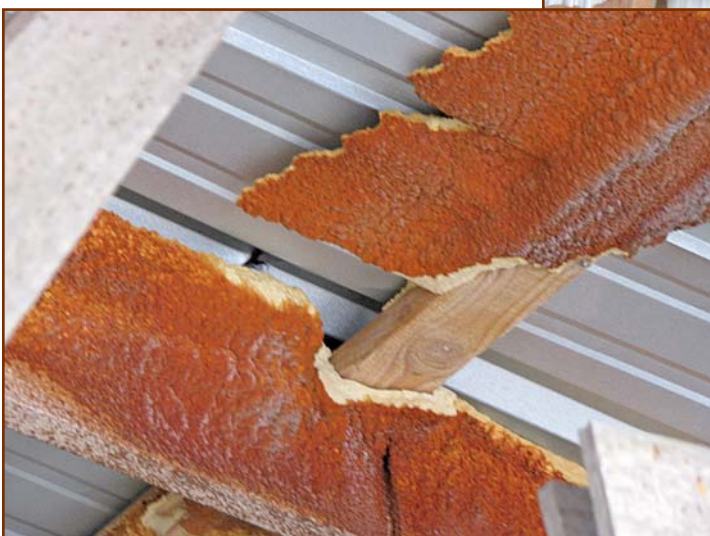
Figure 6 – The ccSPF was removed to install new metal.

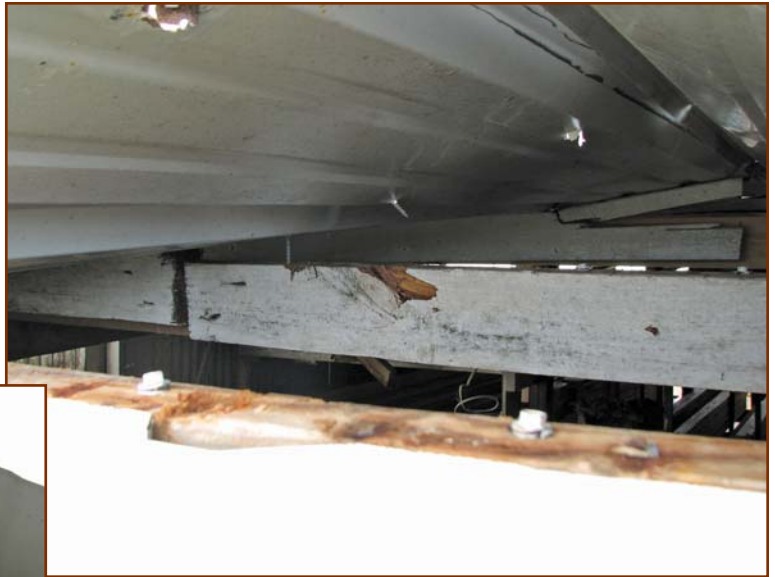
Figures 7 (right) and 8 (below) – Fasteners pulled through the new metal skin where there was no ccSPF to help secure the panels to the wood trusses.

As shown in *Figures 7* and *8*, the main cause of failure of the new metal skin was pulling of the fasteners through the metal.

2. Since 29 gauge is a low-strength metal sheathing material, it is much more likely that fasteners will pull out of such metal, causing damage in a high-wind event. A thicker sheathing might have survived the storm without damage.

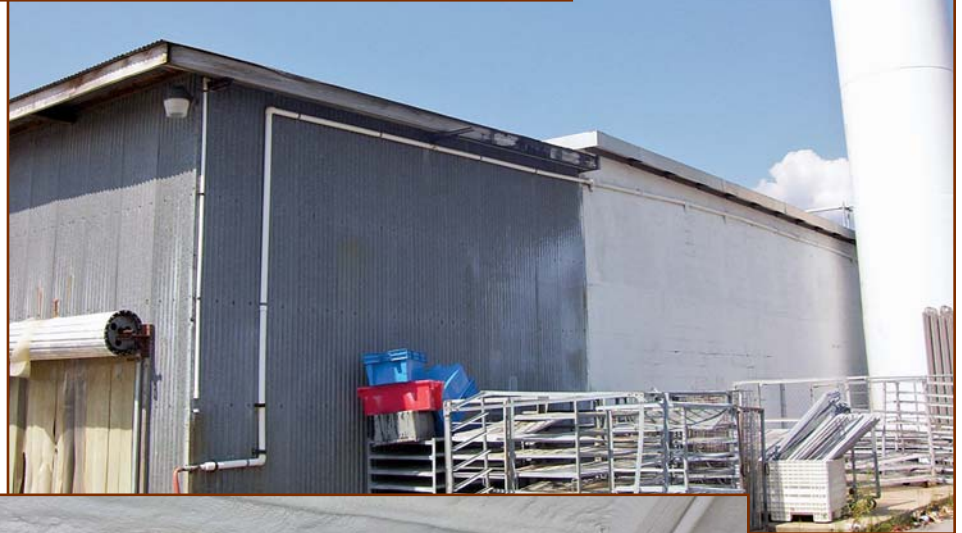
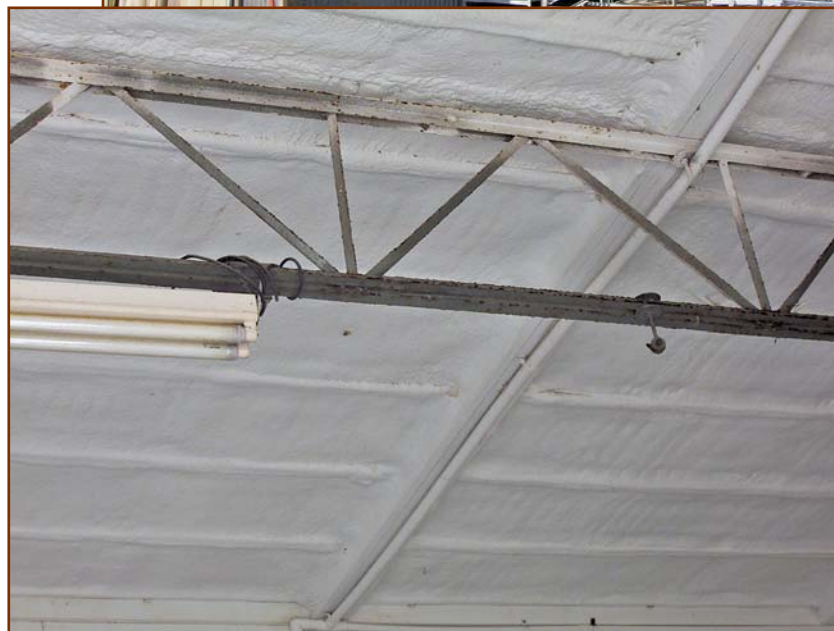
Figure 10 – The metal building below was connected to the structure shown in Figure 9 and was insulated with ccSPF. It received no damage during Hurricane Katrina.

None of the areas insulated with ccSPF sustained any damage. An interesting observation is that many of the ccSPF-insulated portions of the building were areas that would be considered less structurally sound than other areas (if they were not structurally reinforced with ccSPF). Figure 11 shows the foam sprayed against metal roof decking and corrugated metal wall panels.

Figure 11 – Foam sprayed against metal roof decking and corrugated metal wall panels.

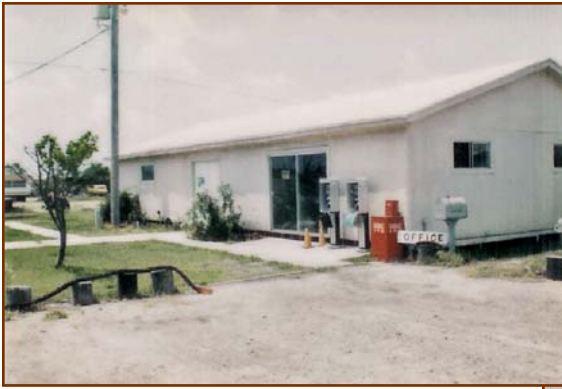
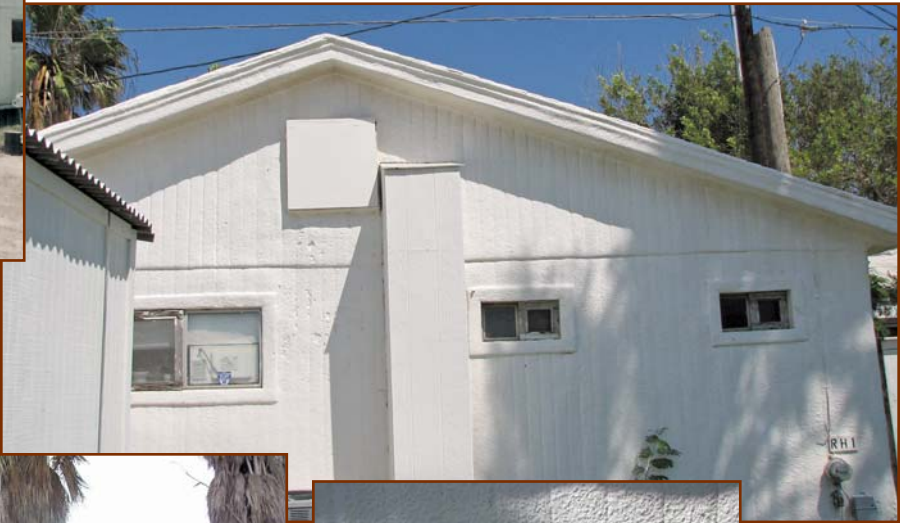
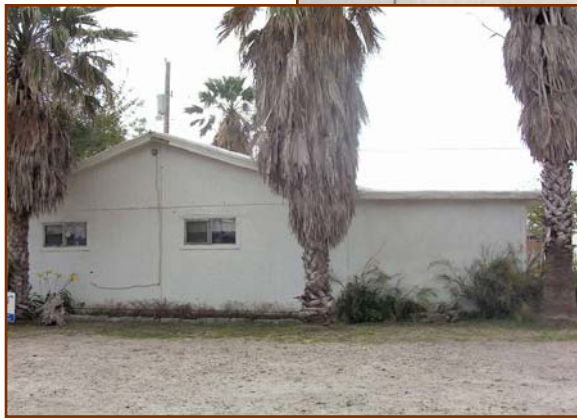
Figure 12 – Port Isabel RV Park, 1979 (before Hurricane Allen).

Figure 14 – Same building after Hurricane Dolly in 2009.

Figure 13 – Same building, 2006.

A recent example of this design is the recreation building at the Port Isabel RV Park. Around 1978, a tropical storm caused damage to the exterior wood cladding, allowing water intrusion into the building. After unsuccessful attempts to correct the problem, the author was contracted to install 1.5 in. of ccSPF to the outside of the entire structure. The application of ccSPF stopped the leaks into the building.

In 1980, the building was directly in the path of Hurricane Allen, a category 5 storm when it hit Port Isabel. Wind speeds were recorded in Port Mansfield (50 miles north of Port Isabel) at 130 knots.⁴ The Port Isabel Press reported two weeks after the storm that the Coast Guard station at Isla Blanca

Park on South Padre Island (one mile from the buildings in Port Isabel) recorded wind speeds in excess of 125 mph. The wood structure survived with no damage and no leaks. Many other buildings in the immediate vicinity were seriously damaged from high winds and water intrusion.

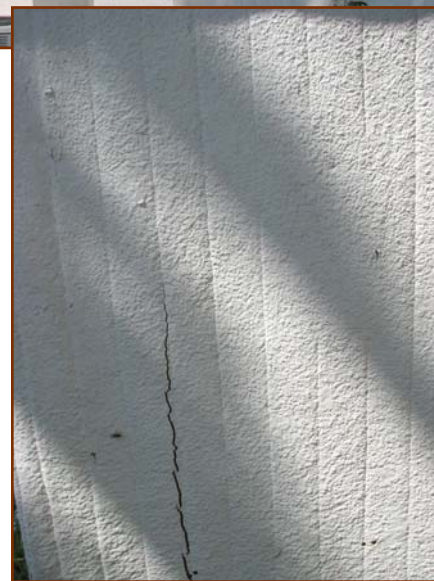
In 2009, the building was in the direct path of Hurricane Dolly, with up to 110 mph winds. Again, the building survived with no damage except for a small crack (see Photo 15) and no water intrusion.

Figure 15 – Only damage after two hurricanes and 30 years of service.

3. Wind-driven debris will typically cause dents, cracks, and gouges to exterior applications of ccSPF. A sealant compatible with the coating can repair small (less than 4 in) mechanical damage. Larger areas of damage can be repaired by removing the damaged foam and replacing it with new foam using high-density foam kits or standard SPF proportioning equipment. Recoating may be required if the damage covers large areas of the structure.

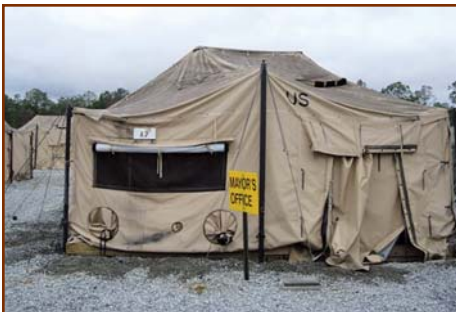
Photo 16 – Example before application of ccSPF.

The Department of Defense (DOD) has an ongoing program to insulate tents and other nonair-conditioned structures in selected bases in Iraq and Afghanistan with 2-lb density ccSPF (Photos 16 and 17). The main goal is to protect against high temperatures in the areas. According to John Siller of the Power Surety Task Force of the DOD, “The foam is providing outstanding performance in this goal.” [Editor’s Note: See “How Insulation Saves Lives and \$\$ in Iraq and Afghanistan” on page 42 for more about this project and the activities of an RCI member

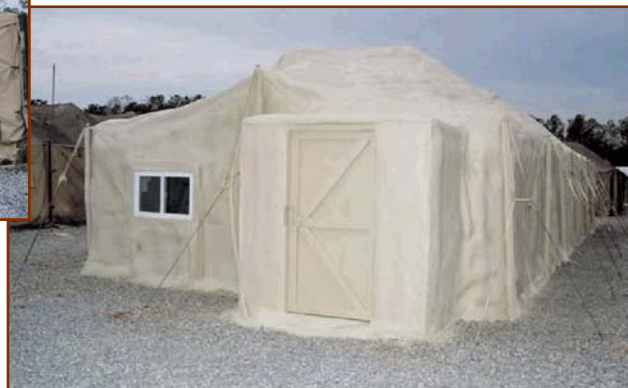
Photo 17 – Example after ccSPF.

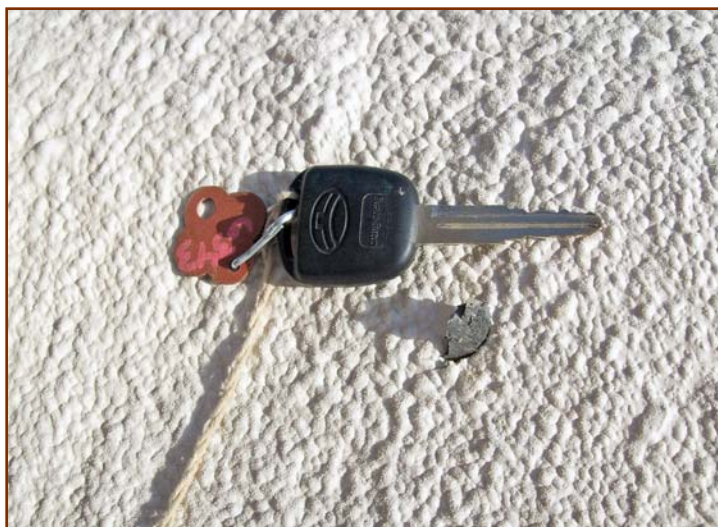
Figure 19 – Shell fragments still capable of severely wounding personnel were embedded in the foam of the structures, 80 to 100 yards away from impact.

But a recent incident may be prompting the military to look seriously at using ccSPF to protect structures against damage from mortars or improvised explosive devices (IEDs). On October 17, 2008, Mearl "Skip" Kline was working with a crew from West Roofing that was insulating tents with ccSPF at a military base just outside the city of Baqubah, Iraq. According to Kline, "The base was attacked by what Army personnel assumed to be 107mm rockets. We hit the ground when we heard the shells coming into the camp. The shells impacted approximately 40 yards from us and 80 to 100 yards away from the ccSPF tents. We were told this type of ordnance has a kill radius of approximately 30 yards. The tents [that were insulated with ccSPF] absorbed shrapnel from the shells without [the shrapnel] penetrating the structures. After the attack, Army personnel were impressed by the

foam's ability to absorb the shock of the shrapnel hits. Many expressed a desire to use the foam to increase the impact resistance from enemy shells." (See *Photos 18 and 19.*)
